Tank *-nically Speaking*

by Marcel Moreau

The Holes in Our UST Systems

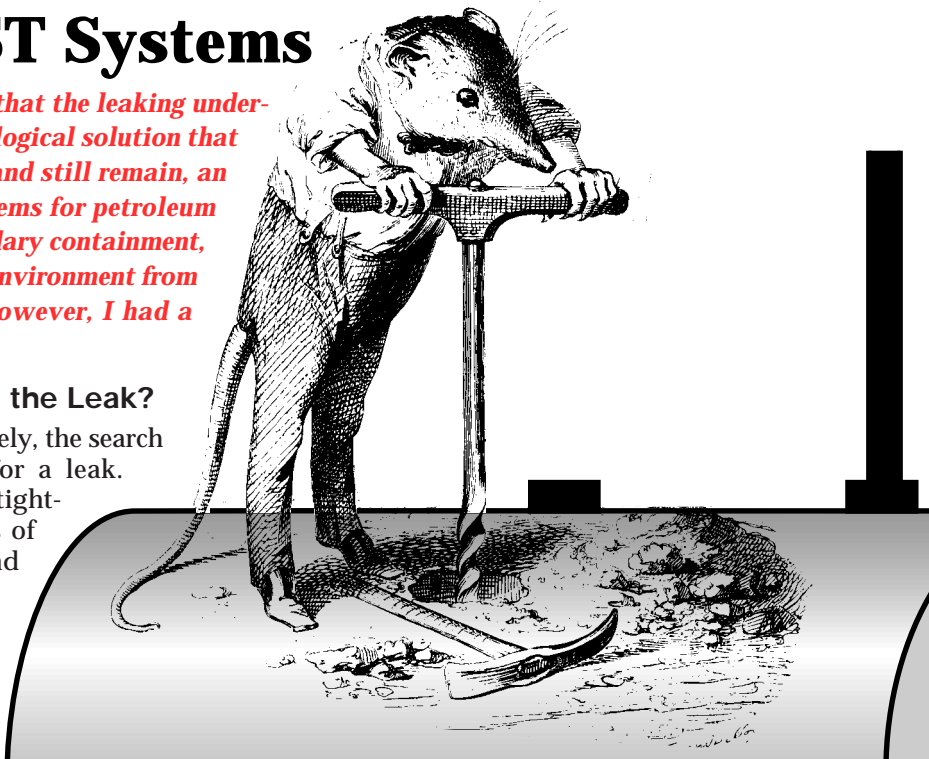
To pinpoint the leak, the concrete mat over the tanks was sawed into large blocks and then carefully lifted off and removed. The gravel backfill over the tanks was vacuumed away so as to leave the piping as undisturbed as possible.

With the tank top and piping exposed, the helium test was repeated. This time, the helium detector was placed right up against the joints and the piping so that the exact location of the leak could be identified.

installer, and several representatives of the tank owner. But no leak was found. A dead end again.
